PRELIMINARY ASSESSMENT REPORT

Doyle, Frank J.

EPA ID NO. TXD980865109

LEONARD, FANNIN COUNTY, TEXAS

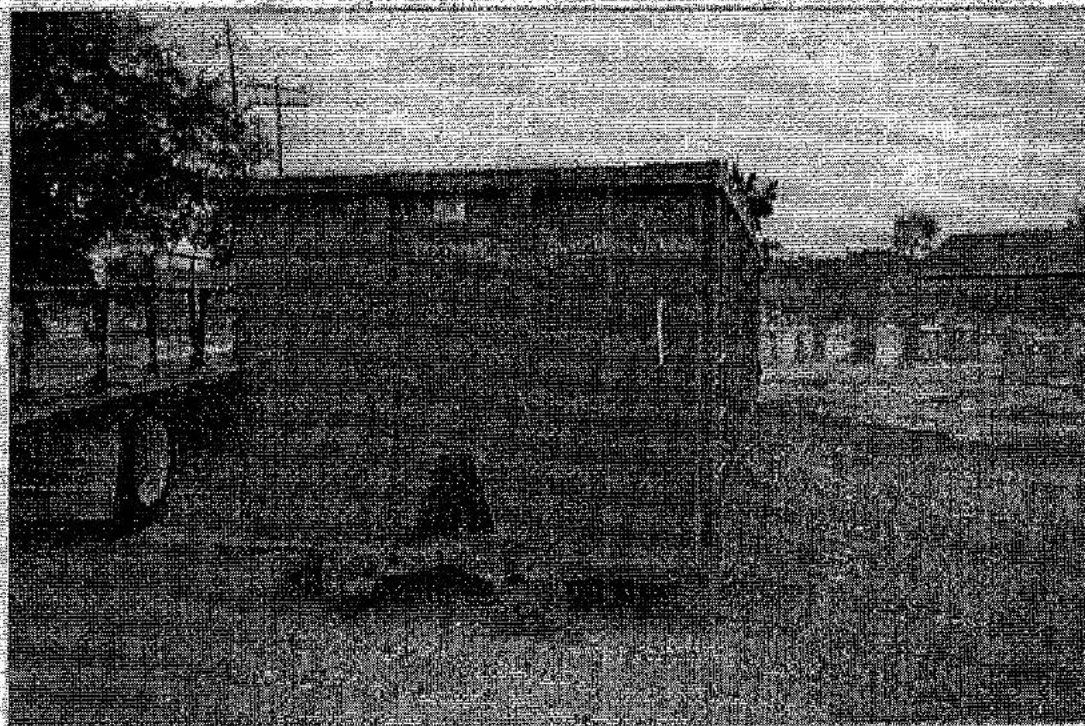
Photo No.
15

Description View along the north side of the shop. Note the staining and the condition of the transformers.
